NASA CR-134355

THIN-METAL LINED PRD 49-III COMPOSITE VESSELS

**THE BOEING AEROSPACE COMPANY
RESEARCH AND ENGINEERING DIVISION
SEATTLE, WASHINGTON**

JANUARY 1974

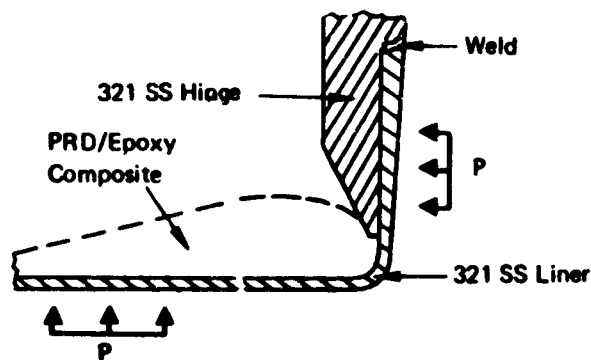
An idealized model of the boss is shown in the following schematic.

Referring to the schematic, pressure is applied over the entire internal surface of the stainless steel liner (including the neck section) forcing the liner to strain with the filament wound composite. Pressure vent holes are provided in the boss body (not shown in schematic) to allow for this action. Computer output indicated the biaxial strain in this region of the membrane induced by the burst pressure was 0.021 in/in (0.021 cm/cm) resulting in a metal membrane stress of 53.5 ksi. ($3.67 \times 10^8 \text{ N/m}^2$).

In the region where the composite "build-up" no longer provides backing for, or strain control of the liner, a structural hinge (short cylinder) is incorporated.

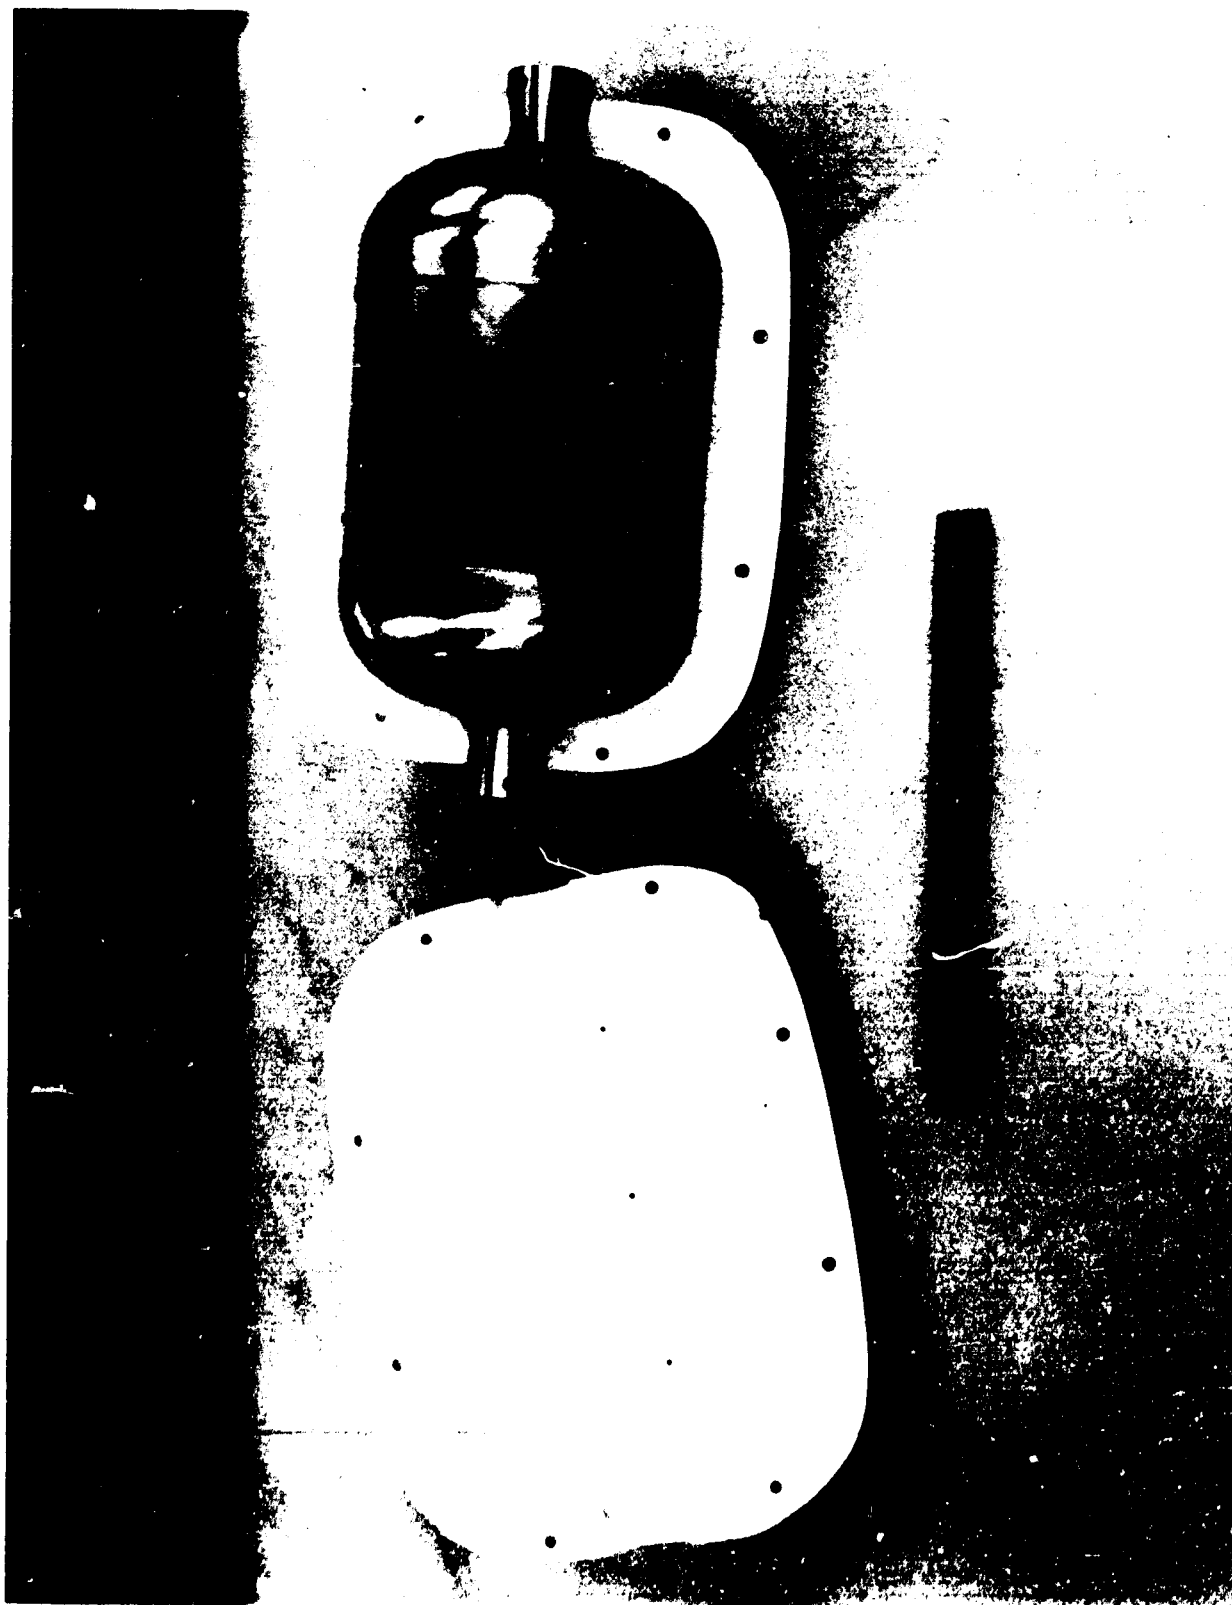
FIGURE 12-LINER STABILIZATION MOLD

In preparation for winding the vessels, the stainless steel mandrel was sized by placing it into a fiberglass mold. This mold, shown in Figure 12, was made to the exact outside contour of the liner. Since the liner was very unstable the sizing mold was used to obtain the correct vessel length and boss alignment. While the liner was in the mold the winding support shaft was installed and secured to the bosses. An internal pressure of 5 psi ($3.45 \times 10^4 \text{ N/m}^2$) was applied to the liner to insure contact with the mold and then final adjustments were made.

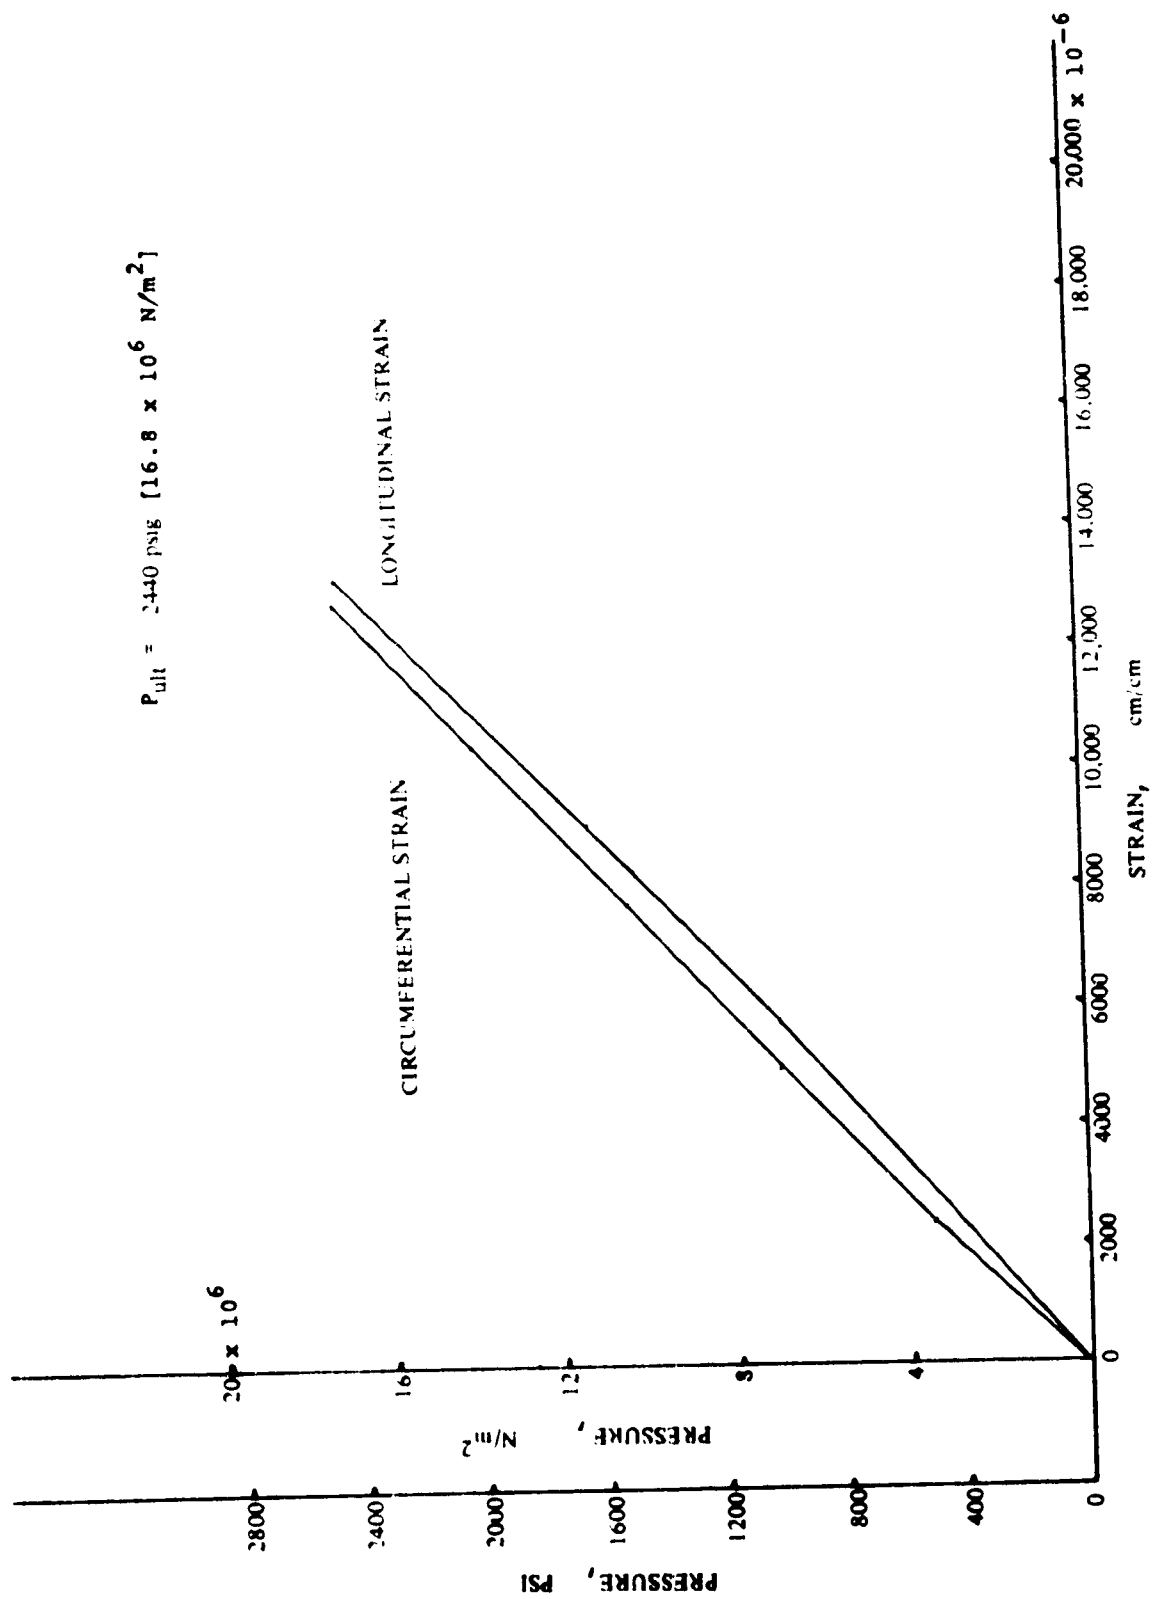
FIGURE 20 PRESSURE VS. STRAIN RELATIONSHIP VESSEL NO. 1

Vessel No. 1 burst at a pressure of 2440 psi (16.8×10^6 N/m²) with failure occurring in the dome (See Figure 19). The circumferential strain was significantly lower than the longitudinal strain, as shown in Figure 20, which is undesirable for maximum fiber efficiency. This poor efficiency was reflected in a low performance factor for the vessel. To force the burst into the cylindrical section of the vessel, the number of circumferential windings were reduced from 800 to 760 yarns/inch (315 to 300 yarns/cm) for Vessel No. 2.

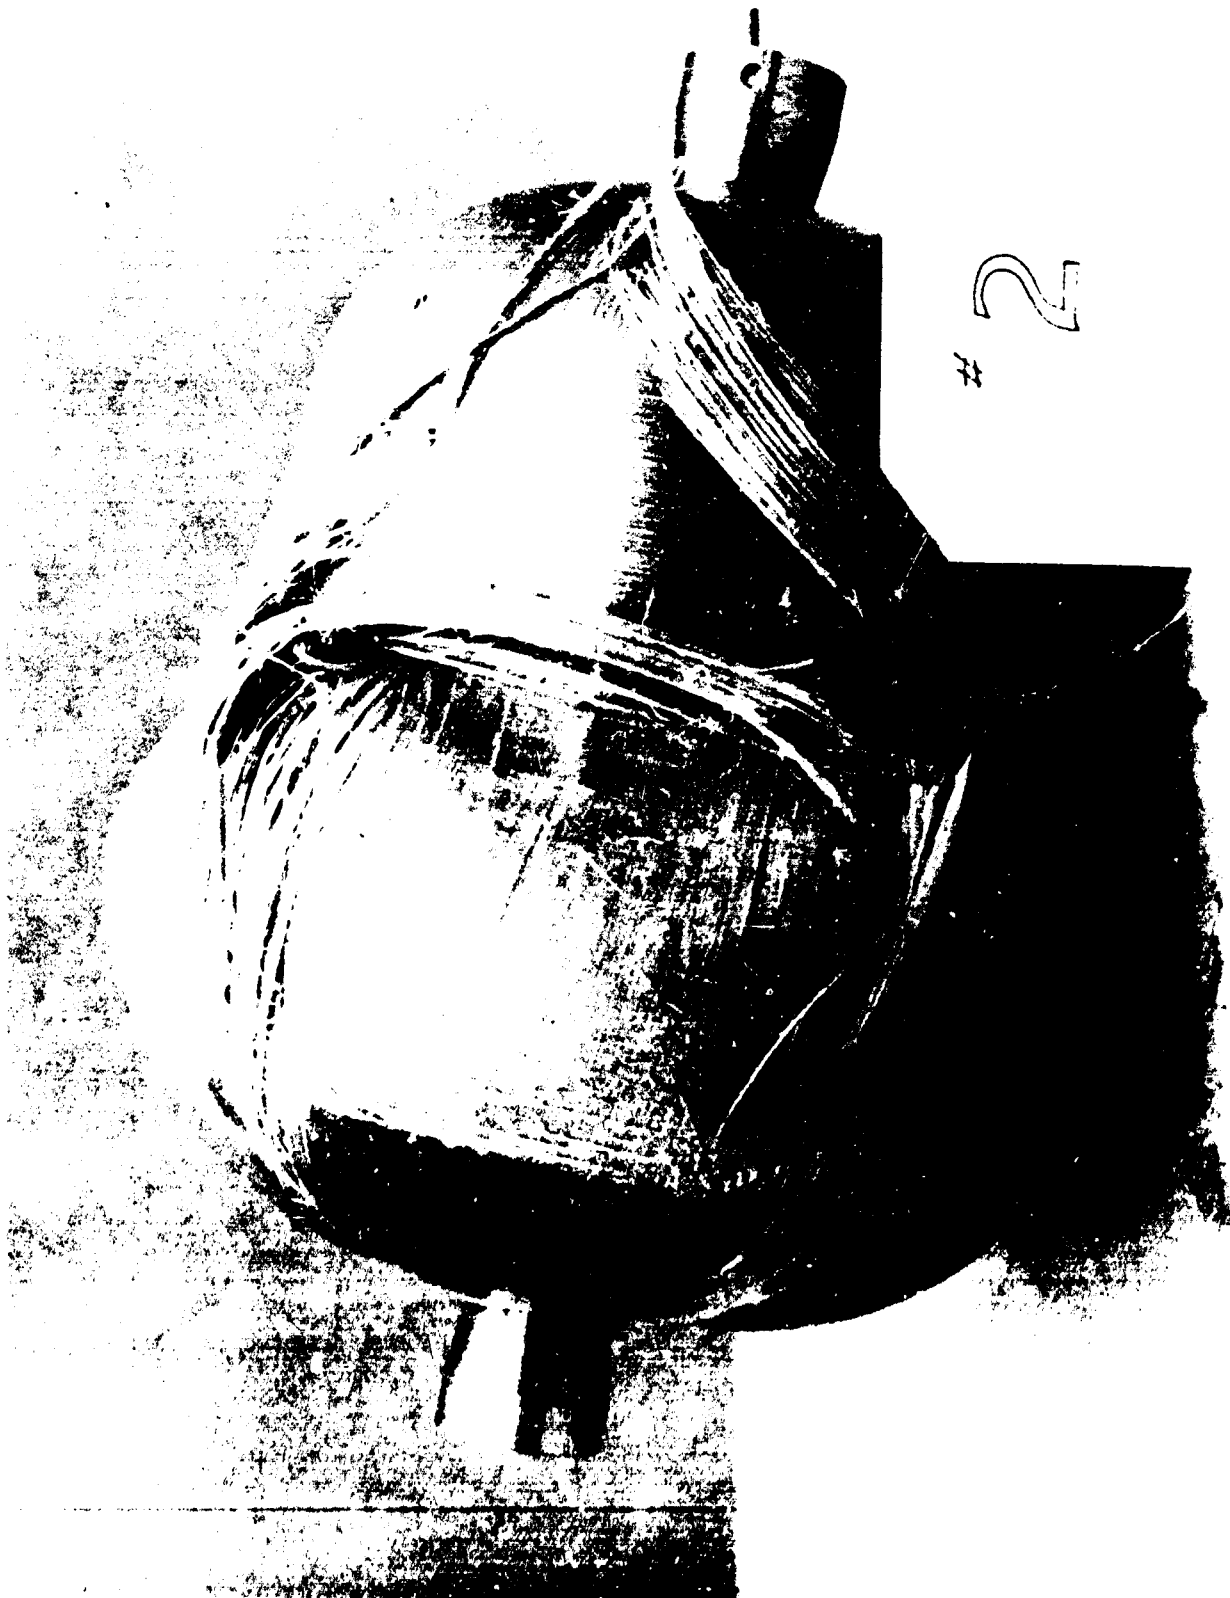
FIGURE 21—VESSEL NQ.2 AFTER BURST TEST

Vessel No. 2 did fail in the circumferential windings as desired (Figure 21) at a pressure of 2750 psi ($19.0 \times 10^6 \text{ N/m}^2$). This provided a very good performance gain; however, after reviewing the stress-strain behavior of the tank (Figure 22) it was evident that further optimization could be obtained by lowering the burst pressure. In Vessel No. 3, to lower the burst pressure, the longitudinal fiber count was reduced from 402 to 321 yarns/inch (158 to 126 yarns/cm) and the circumferential count reduced from 760 to 608 yarns/inch (299 to 239 yarns/cm).

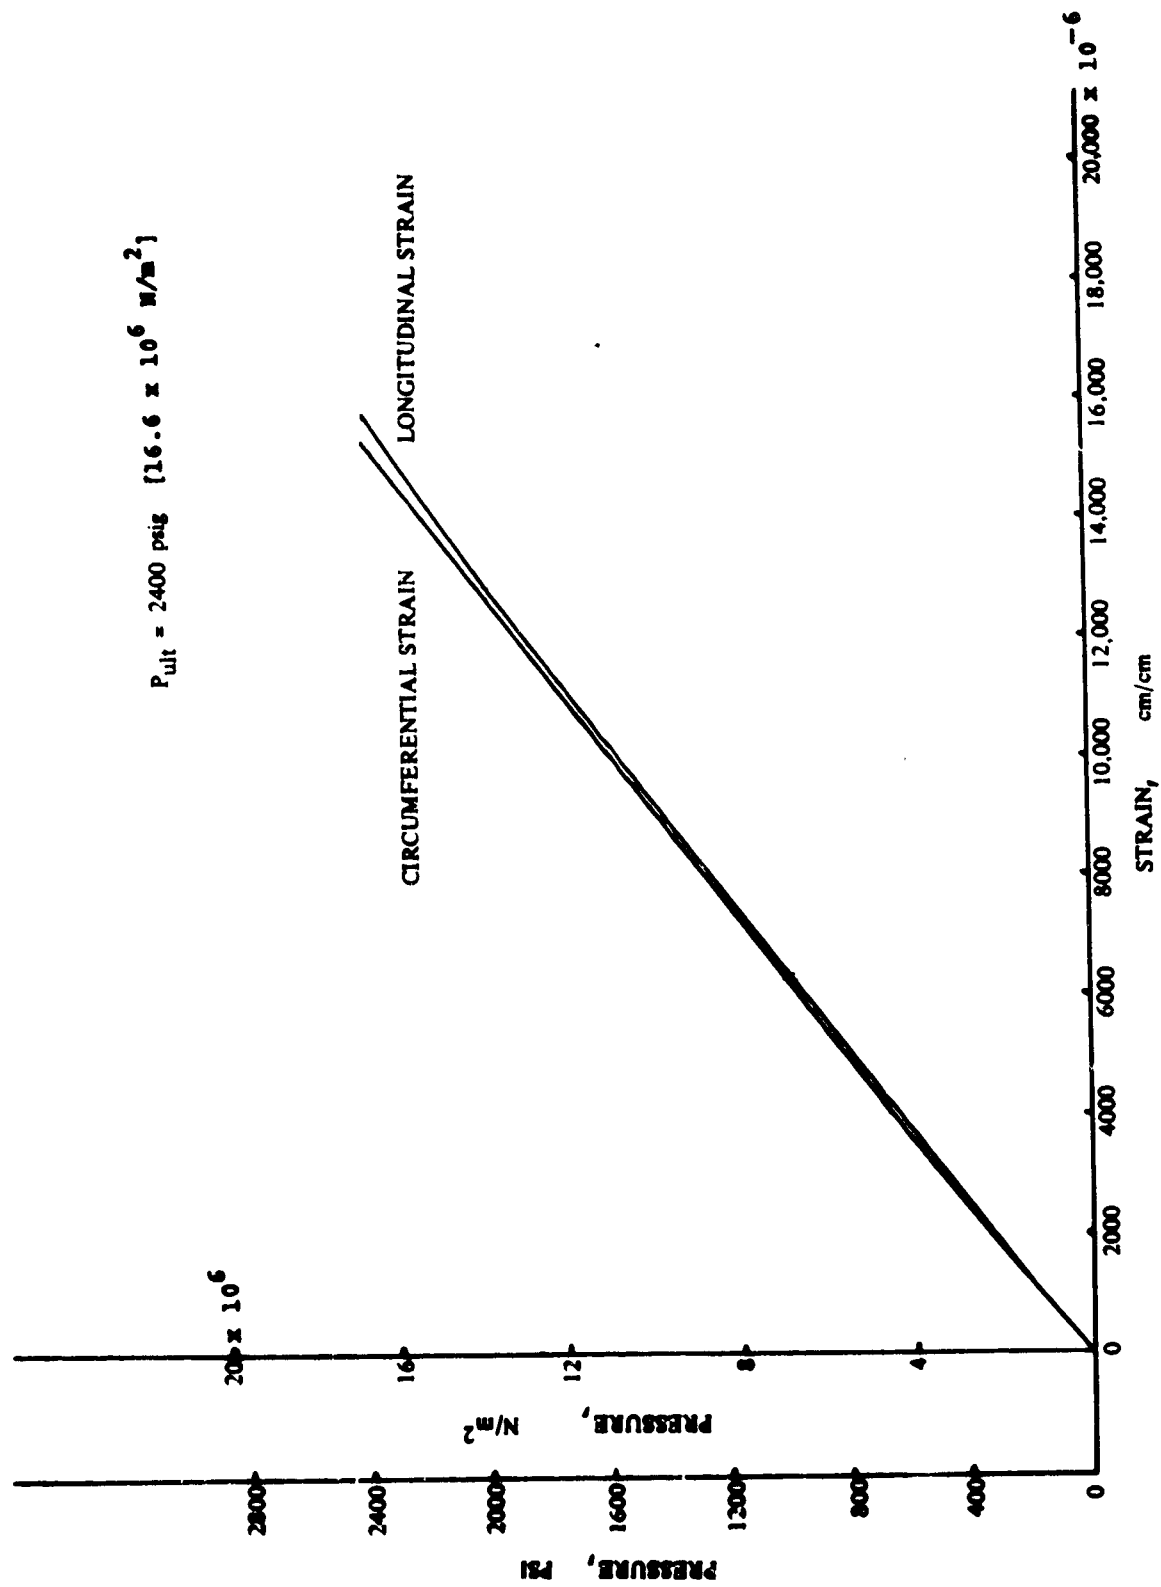
FIGURE 23 PRESSURE VS. STRAIN RELATIONSHIP - VESSEL NO. 3

Vessel No. 3 failed at a burst pressure of 2400 psi ($16.6 \times 10^6 \text{ N/m}^2$) with a performance factor of 1.73×10^6 inches ($4.39 \times 10^6 \text{ cm}$). The pressure vs strain relationships are shown in Figure 23. The vessel gave the desired strain behavior and it was decided to use the design of this particular vessel for the remaining tanks and concentrate efforts towards solving the liner buckling problem that was occurring during fabrication (see Section 3.2.2). Vessel (No.3) is shown in Figure 24.

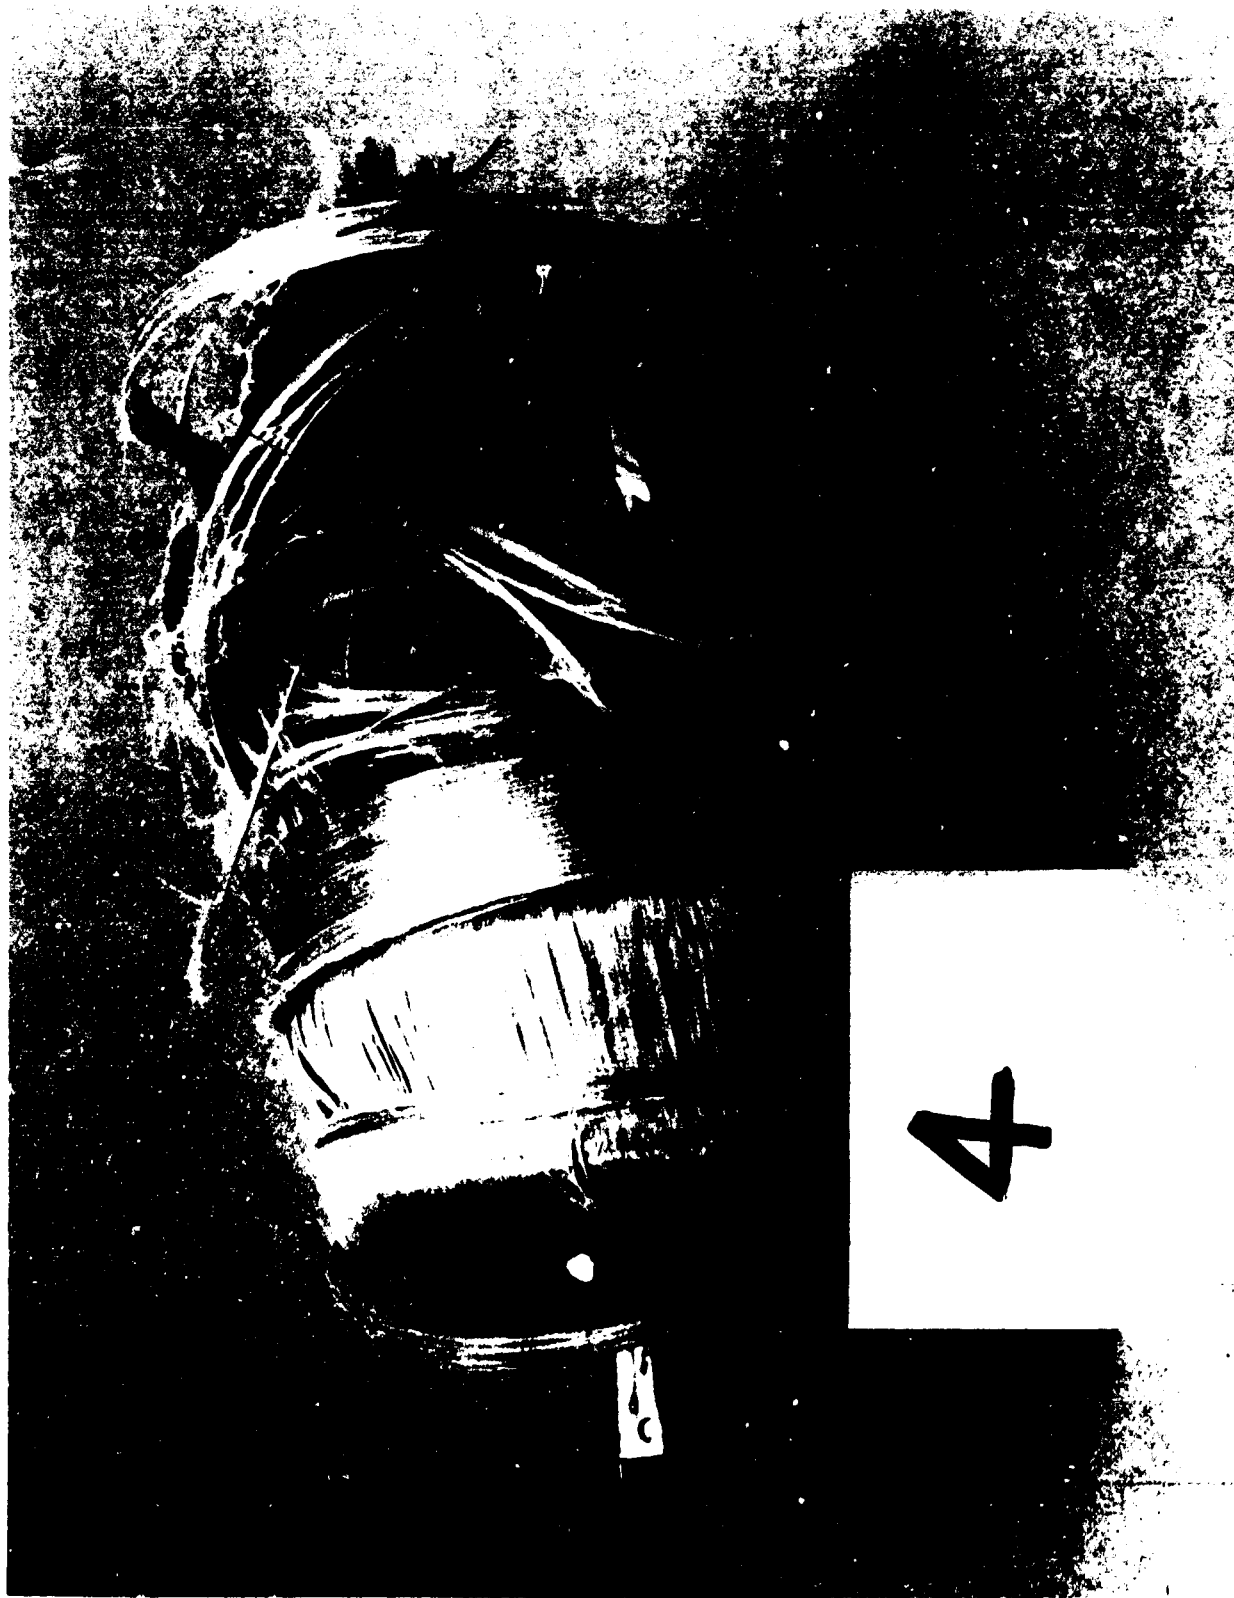
FIGURE 25 - VESSEL NO. 4 AFTER BURST TEST

Vessels No. 4, 5 and 6 failed at values of 2640 psi ($18.2 \times 10^6 \text{ N/m}^2$), 2520 psi ($17.4 \times 10^6 \text{ N/m}^2$), and 2680 psi ($18.5 \times 10^6 \text{ N/m}^2$) respectively. These vessels are shown in Figures 25, 26 and 27 with the corresponding stress strain curves shown in Figures 28, 29 and 30. The vessels, although fabricated from different resin systems or exposed to different cures, showed no significant differences in burst strength (Table VII) and gave very good performance factors [$(>1.75 \times 10^6 \text{ in.})$ ($>4.45 \times 10^6 \text{ cm}$)].
